FAILURE ANALYSIS FOR HIGH STRESS GEAR

Abstract-Gear failure is one of the most headache problems in the industry particularly when it is occurred during the critical operation season of the industrial systems. One of these situations was occurred during the season of sugar industry. The gear was manufactured from carburized steel DIN standard No.1.6587 (18CrNiMo7-6). The gear, module is 5.08 mm, pressure angle is 20°, No of teeth is 16, width is 85 mm and helix angle is 8.5° Right with mating gear No of teeth is 70 teeth. The failure was occurred within 1 month of continuous operation. The gear is driven by 315 kW motor at 1450 rpm. A visual investigation has been carried out, a set of photos were taken and the working conditions were reviewed. The visual investigation showed that the pinion has undergone some broken teeth at the pinion and pettings in the mating gear. The operating conditions have been revised during consecutive intervals of operation. The design data has been reviewed according to standard gear design recommendations. Material analysis and micro hardness measurements followed by a micro structure have been also investigated. The micro hardness survey through the

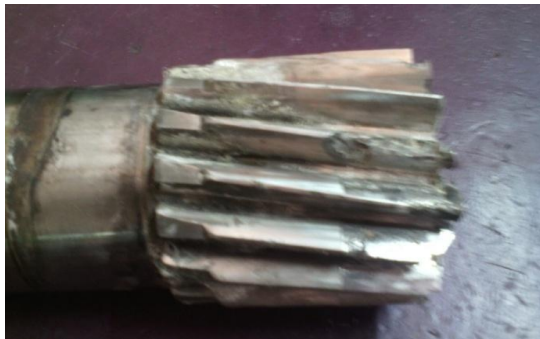
The visual observation of the pinion gear after failure had shown that many teeth were broken at the tip section of the teeth and pitting was noticed through the teeth. see figures (1, 2, 3). Notice that most of pinion broken teeth at the tip.

Fig. (1) Pinion gear teeth failure

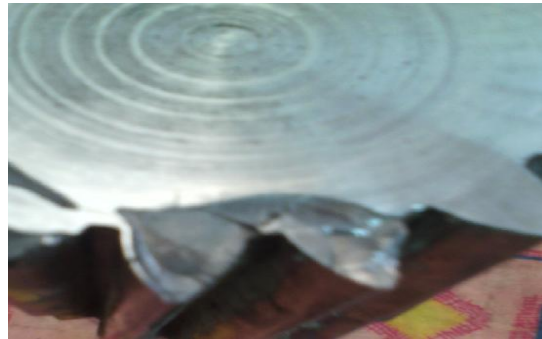
Fig. (2) Pinion gear section failure

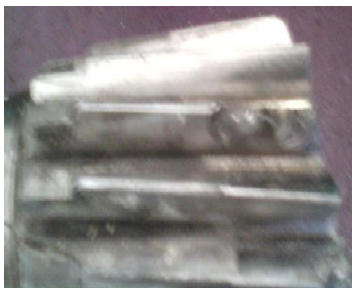
Fig. (3) Pinion gear pitting and failure

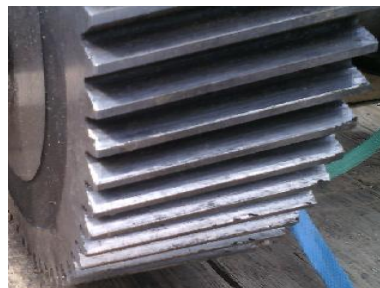
Fig. (4) mating gear teeth pitting

The mating gear teeth had pitting as shown in figure (4) but no complete tooth was broken.

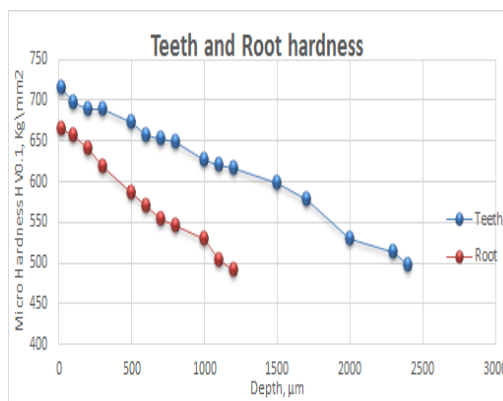
Fig. (5) Pinion gear micro-hardness

A micro hardness $HV_{0.1}$ kg (kg_f/mm^2) test was carried out for pinion through both the teeth section and the area between teeth at the root at which has the maximum bending stress position. The results were then tabulated and presented in the following table (table 2) and figure (5) which show the measured data of the pinion gear.

The surface hardness $HV_{0.1}$ of the Gear = 715 Kg/mm^2 , while the core hardness of the original gear = 401 Kg/mm^2 . The case depth on the teeth tip of the original gear = 2.3 mm, while the case depth at the teeth root = 1.05 mm. The effective carburizing depth is considered at $HRC=50$ or $HV= 513$ (Kozlovskil et al [12]).

The material analysis confirmed suitable material as required, microhardness survey of the pinion had revealed that a carburizing case depth at the teeth was not confirming the recommended values of references [17,18] because the depth equal 2.3 mm and it is much greater than the recommended suitable to the case data which causing the carburizing case is full hardened portion at the tip of the teeth. So, this portion miss its toughness and could not resist impact load. Also too much case depth makes the gear teeth more brittle with the tendency to shatter off the top of teeth [19]. All the above circumstances caused initiation of cracks and it was propagated until failure is occurred. This type of failure is classified as tooth bending fatigue failure [20].

- ✓ Carburizing depth 2.3 is very big which lead to brittleness and crack initiation lead to failure [21].
- ✓ The dynamic factor K_v and surface condition factor Z_R are highly affected by the pitch variation accuracy so; the gear teeth must be grinded. AGMA2101-C95
- ✓ The geometry factors Y_J , Z_I must be improved AGMA 908 - B89
- ✓ The profile displacement of gear larger than the pinion it is against the DIN 3960 recommendations [22].
- ✓ The size factor could be improved by increasing the module [23].
- ✓ Take care from increasing the pinion number of teeth because that has a disadvantage concerning the bending stress [24].
- ✓ Redesign the gear box using the available reduction stages in the gearbox casing.

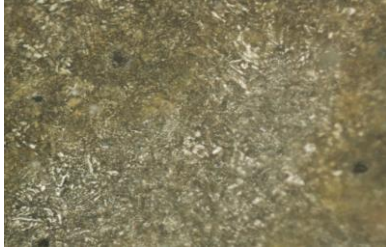
Optical microscope with X500 magnification power was used in investigating the microstructure; Nital Etching 2% of the specimen. The microstructure of the pinion gear at the case of the teeth are shown in figures (6).

Figure (6) shows tempered martensite with small amount of retained austenite.

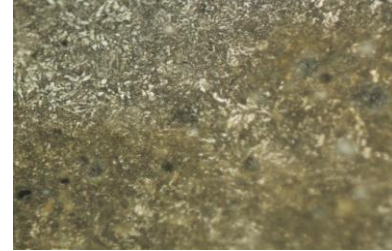
Fig. (7) Pinion gear teeth root microstructure

The microstructure which reveals small amount of martensite; black points in the microstructure.

The microstructure of the manufactured gears, as shown in figure (7) at teeth root reveals an amount of tempered martensite with small amount of retained austenite.

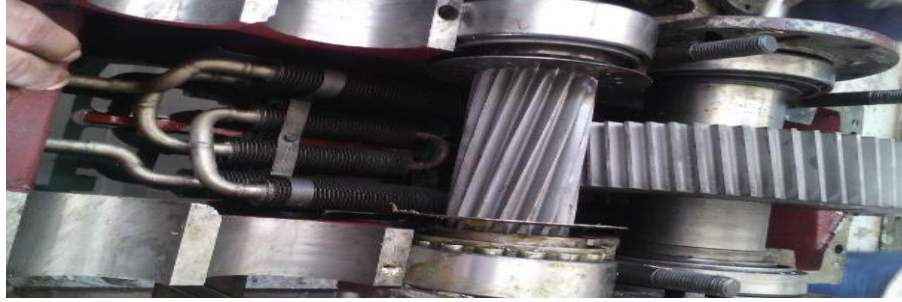
Then there are two main problems in this case study; the big layer of carburizing case has to be carried out with the correct value and, the high level of; contact and fatigue stresses lead to the fast failure of the gears and must be investigated for solving it in the future. It is clear that high stresses come due to an error of design or an error of the gear box modification specially, it was used a single stage reduction while the gear casing has a multi stages axis as shown in figure (8).

Fig. (8), a multi stage casing

The gears have mainly two problems; first is the big carburizing case depth which leads to brittle teeth tip and this could be changed to the suitable depth and, second is the high contact and bending stress levels and this required reanalysis of the gear box design specially the gearbox casing has multi stage gearing instead of the used single stage gearing.
