THE FAILURE STUDY OF BED ASH SILO A CASE STUDY

Abstract- Silo collapses is common in the industry. It also gets deformed or distorted during use. A conical RCC hopper of the bed ash silo of 2X62.5MW failed prematurely without occupational hazard. In this case, failure occurred as the RCC hopper got separated from RCC ring beam. The failure was analyzed considering design, construction workmanship, material used, operation, and maintenance. This is a suspended cone hopper. However in the recent designs the cone hopper is supported from below by a reinforced concrete ring slab and sides are filled with concrete. During erection and construction of RCC, fault occurred in and around ring beam and suspended hopper joint. In joint area porous concrete was seen and it caused cracks in concrete. It is due to lack of approach and poor compaction. The ingress of air and moisture into the concrete face corroded reinforcement bars. Incorrect steel rod binding and improper development length results in insufficient concrete cover. The bars were placed out of position or in the wrong position. In this case the reinforcement bars got sheared and yielded at the junction of the hopper and ring bea

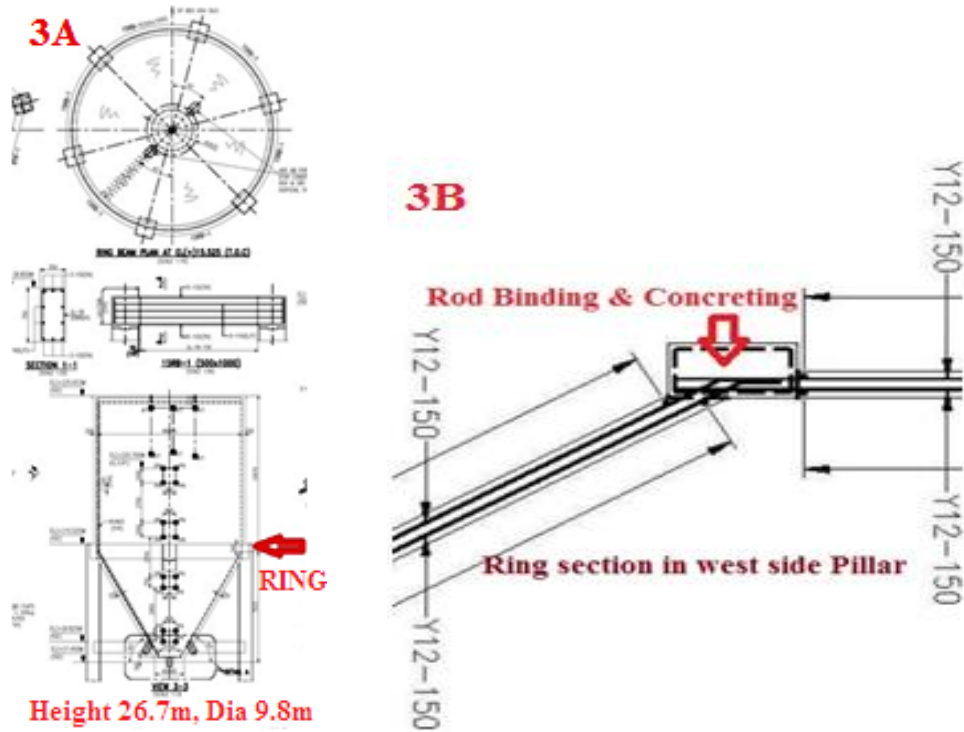
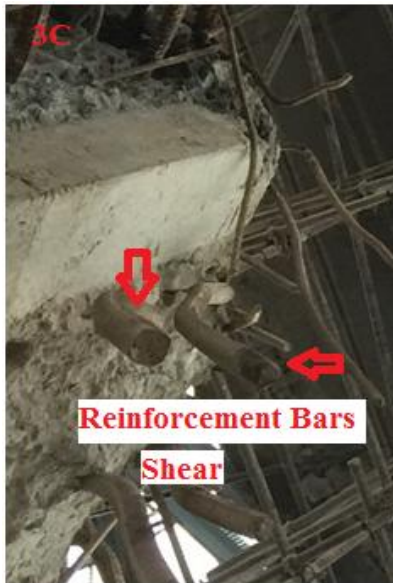
Figure 3a B C: Junction Of The Hopper And The Ring Beam

In the figure-3A arrow mark shows the joint at which the RCC hopper is suspended and connected to straight portion of silo. The figure-3B shows the rod binding and concreting area. The workmanship needs to be perfect here with standard quality checks. The hopper is suspended from ring beam. It has no support at bottom FIGURE-3A. During erection and construction of RCC, main fault has occurred in and around joints. In joint area if concrete is not properly compacted by ramming or vibration and the result is a portion of porous honeycomb concrete. This sort of defect is caused by lack of approach, hence poor compaction while erecting or onsite joining. Complete compaction is essential to give a dense, impermeable concrete at the joint marked with arrow.

figure 3B Poor joint allowed ingress of moisture to the concrete causing corrosion in steel. The corroded reinforcement bars has sheared and yielded at the junction of the hopper and ring beam. This sort of defect causes cracks in steel. The faulty concreting is due to lack of approach and poor compaction while erecting or onsite joining.

Incorrect steel rod binding can result in insufficient cover FIGURE-3C. If the bars are placed out of position or in the wrong position or proper development length for rod is not given, collapse can occur when the element is even partially loaded. The cracking of the concrete is common in the joints. Through these thin cracks ingress of moisture, gases and other substances

caused corrosion of the reinforcement bars. The corroded and thinned reinforcement bars got sheared when it is partially loaded.

2. The bed ash silo collapsed due to **shearing of reinforcement bars** at the west side junction of ring-beam and hopper of silo at a level of +EL 14.5m.

3. The steel reinforcement bars were out of position at the hopper and ring beam junction. Proper anchoring got affected due to faulty positioning and development length of reinforcement bars during erection.

4. The reinforcement bars joints did not fit together properly; joint area concrete is not properly compacted causing porous concrete. The porous concrete due to entrapment of moist air developed corrosion and hair line cracks in steel and further extended gave way at time of loading.

5. Inadequate cover of reinforcement has permitted ingress of moisture, gases and other substances causing corrosion of the reinforcement bars and shearing. The shearing of reinforcement bars caused collapse of silo as shown in FIGURE- 3C.

This is a suspended cone hopper. However in the recent design the cone hopper is supported from below, by a reinforced concrete ring slab and concrete filling.
