Use of Geosynthetics in Restoration and Bank Protection from Dhola-Hatiguli to Rohmoria along the River Brahmaputra - A Case Study

Abstract- Flood management and bank erosion control has become a prime matter of concern due to its devastating impact in life and property. Many anti-erosion techniques are used as engineered solutions to the problems. This paper highlights the source, flow regime, complex and unique soil erosion characteristics of the Brahmaputra River and describes the case studies where Geosynthetic are used as erosion control measures and their effectiveness at two different reaches (Rohmoria & Dhola-Hatiguli) along the Brahmaputra River. The Geosynthetic materials used as preventive measures were tested at CSMRS, New Delhi as per project Quality Assurance plan and presented in this paper along with advantages of using Geosynthetics materials.

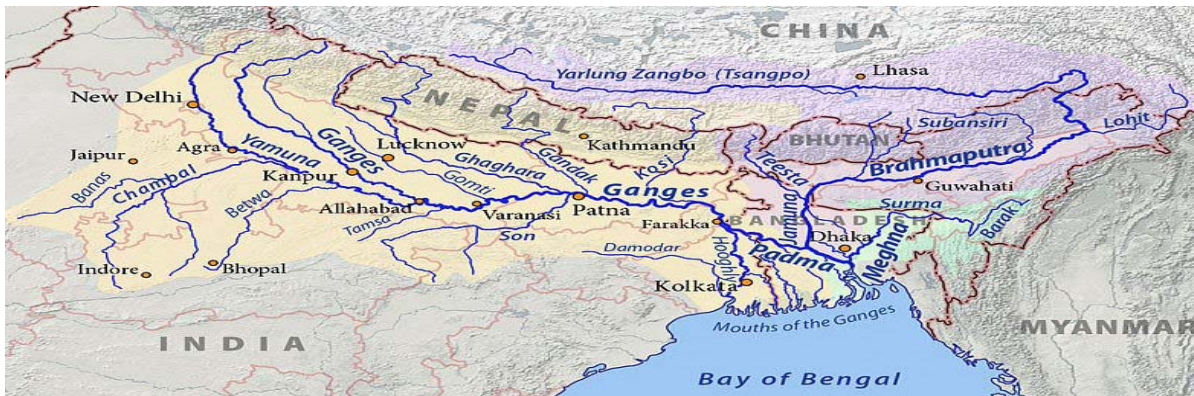
Figure 1. Brahmaputra River System

In India, the Brahmaputra River flows southerly and westerly through the states of Arunachal Pradesh and Assam over a distance of approximately 918 km. In the Himalayas range before entering India, the river is known as the Tsangpo River flowing from west to east, then south through the eastern Himalayas as the Dihang River. In Assam, the Dihang River is joined by Dibang and Lohit River also know as start of Assam valley to form the Brahmaputra River. Near the western boundary of Assam, the river turns south to enter Bangladesh changing its name to Jamuna till its confluence with the Ganges from where both the Jamuna and Ganges form the Padma flowing into the Bay of Bengal. The total length of the river in Bangladesh is approximately 363 km.

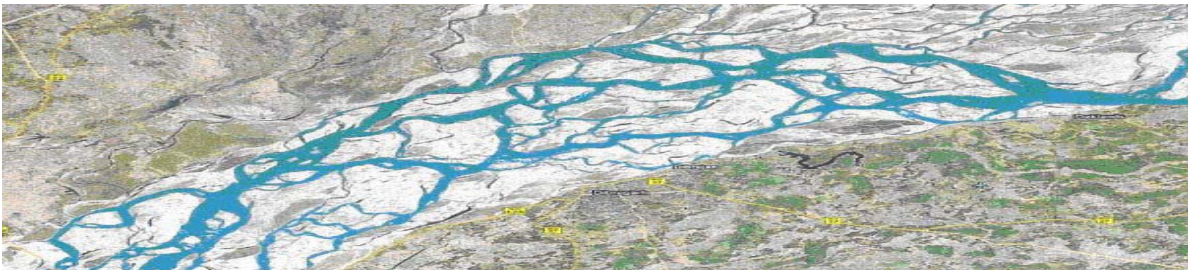
Figure 2. Braided channels of Brahmaputra Rive

A longitudinal bank profile of the Brahmaputra presented in Goswami (1985) reveals that the river has a gradient of 0.09 to 0.17 m/km near Dibrugarh, Assam at the start of the Valley and it reduces to about 0.1 m/km near Guwahati. Through Assam, the long term average discharge increases from 8,500 to 17,000 cubic meters per second as flows are augmented by major tributaries. The width of the river varies from one km on an individual channel to as much as 10 km in some reaches with multiple braided channels. Almost through its entire length in Assam, the river has three to six channels separated by islands and mid-channel bars under low flow conditions. These bars and islands become submerged during major floods. The pattern of channels changes frequently under flood conditions accompanied by extensive erosion of banks and disposition of sediment forming sand bars. Figure 2 presents the typical braided channels of the Brahmaputra River.

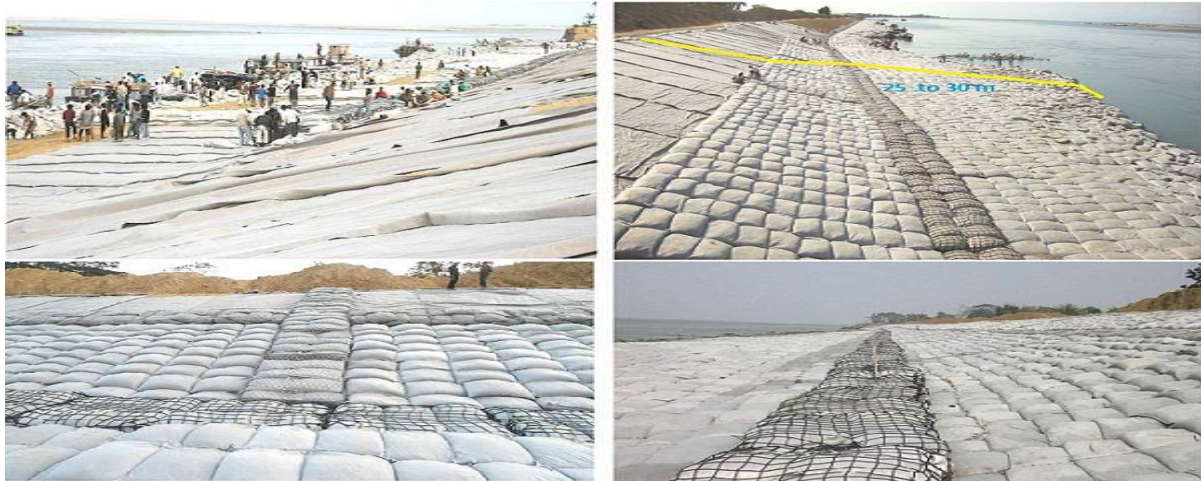
Figure 5. Placement of filter media, Geobags & PP Gabions

Major portion of construction of launching apron and key was carried out underwater. This was carried out using suitable vessels and appropriate placing methods. Further, the river bank was dressed to the inclination of 1V:3H and over this a layer of non woven geotextile was laid as filter media. After placement of geotextile filter, Geotextile bags were placed along the length on the bank. Strips of gabions filled with Geotextile bags were introduced at specified intervals (Figure 5). Total quantity of filter material was 64300 m² and Geotextile bags for the protection works was approximately 8,20,000 numbers and these were placed at the rate of 4,000 number of bags per day. The work was completed in six months from October 2011 to April 2012, with an average placement of 1,25,000 numbers of bags per month.

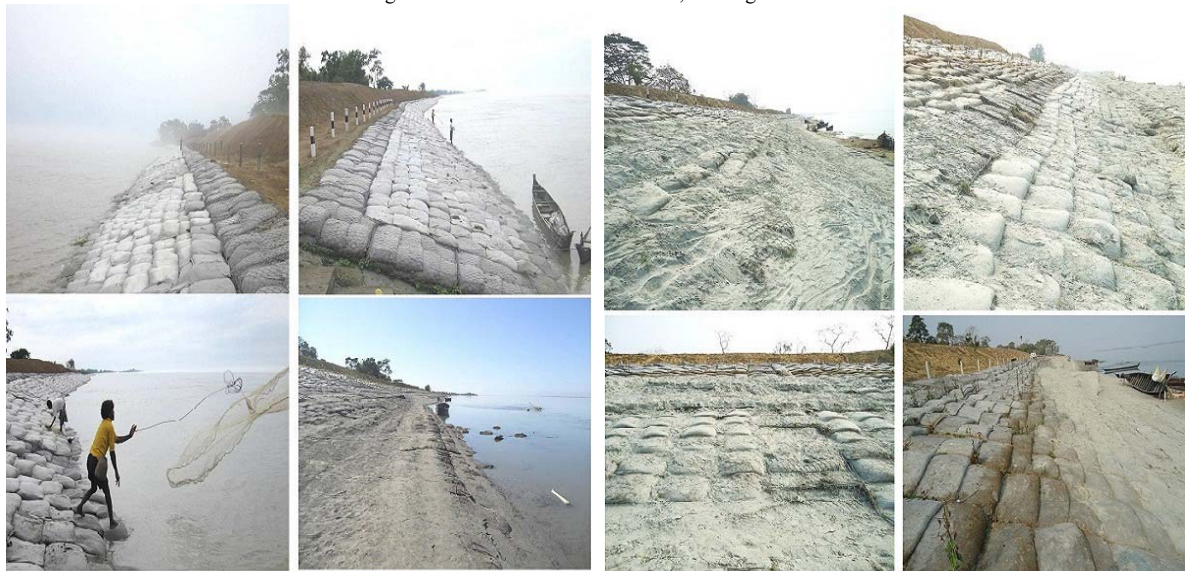
Figure 6. Bank condition during flood

Figure 7. Silt deposit on bags after flood

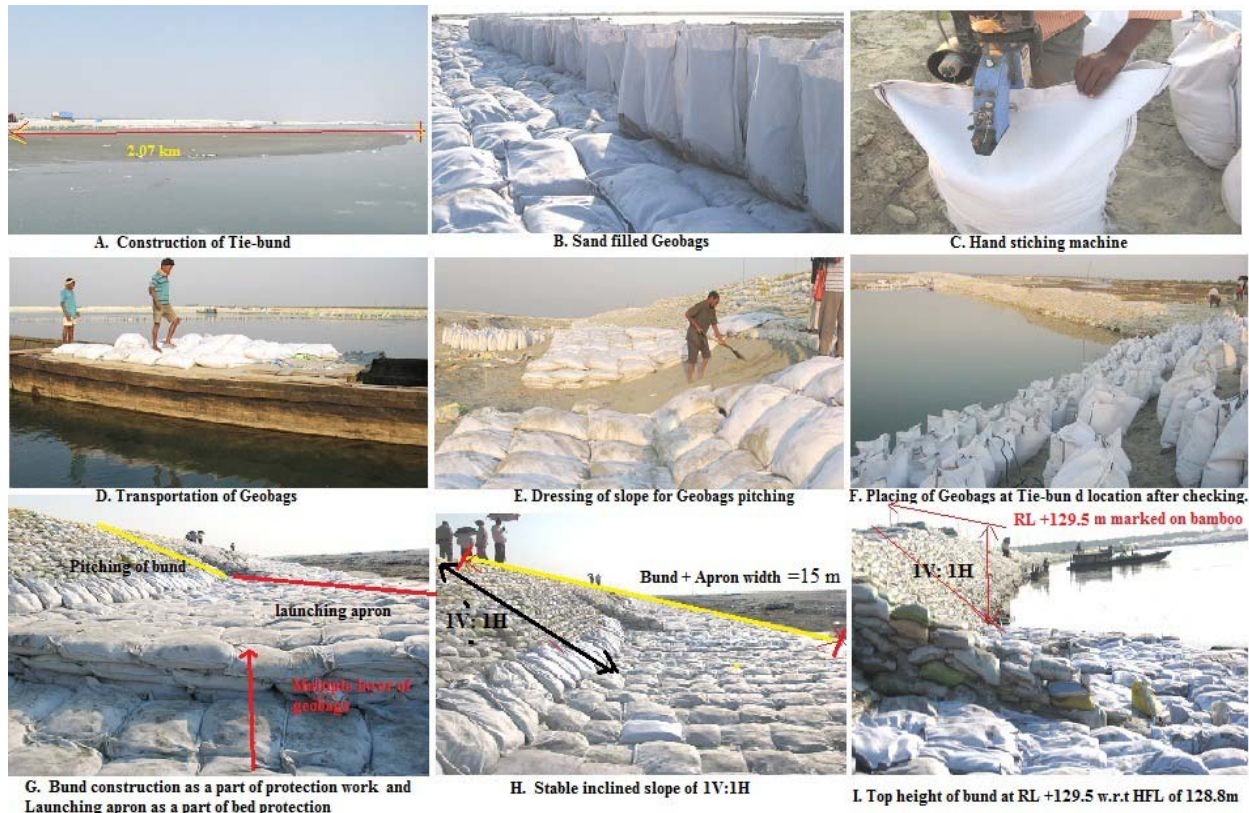
Figure 9. Implementation of Non-woven Geotextile bags.

Non-woven Geotextile bags were filled with sand to the specified height to ensure that appropriate density is achieved by filling. At a given stretch, number of bags were filled and stacked suitably for checking and verification. This was a part of quality assurance and compliance procedure that was followed during the installation activities. After ensuring the bags were filled to the required height, the open ends of the bags were closed by stitching the bags at location using hand stitching machines. Stitched bags were manually loaded on boats for further transportation to the site location for installation. The sequence followed for the construction was placing of sand filled Geobags in multiple layer for launching apron, key construction and placement of sand filled Geobags in multiple layer on the bund. Construction of launching apron and key was carried out partly underwater. This was carried out using suitable vessels and appropriate placing methods. Further, the tie- bund was dressed to the inclination of 1V:1H and over this a multiple layer of non-woven geotextile bags filled with sand was laid. Figure 9 shows implementation of non-woven geotextile bags at various stages.

On an average, 100 labors were deployed for filling, stitching, loading and placing of bags. Around five numbers of boats were used to transport filled bags from filling area to installation location. Total quantum of geotextile bags for the protection works was approximately 2,00,000 numbers and these were placed at the rate of 1,000 numbers of bags per day. The work was completed in 8 months from December 2012 to August 2013, with an average placement of 25,000 numbers of bags per month.
