Productivity Improvement in Engine Assembly Line at GM India Ltd. Pune, India

Chirag K. Deotare

Uday A. Dabade

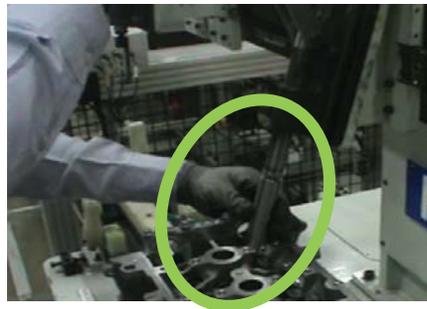
Fig. 6 Photograph of Manual Operating Process with New Tool

The manual operating process shown in figure (Fig. 6) is installed for BDHOC engine by installing this tool and troubleshooting related to head sub-assembly line the observations noted are:

- By installing manual new tool, rework for BDHOC engine is reduced to 0%.
- By applying troubleshooting noted in Table II efficiency is improved to 20% (from 60% to 80%).

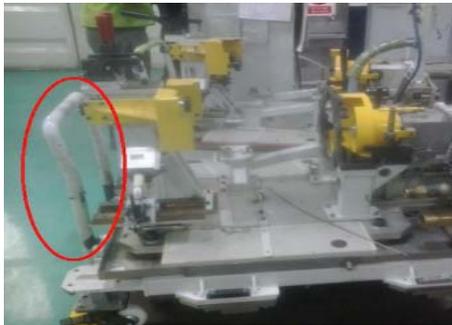
Fig. 8 Cart Handle Before Implementation

The cart handling in hot test cell extra effort requires to push/pull the engine test cart so it was not significant job for the operator to handle it and results in fatigue of operator and turning moment requires for operation was more resulted in over motion. Test cart handle modification done so as to reduce the pull and push force, bending movement of operator.

By mathematical analysis (classical mechanics approach), and by selecting different planes as in figure (Fig. 7) we calculate forces required using translational and rotational motion to handle cart accordingly cart before implementation and after implementations photos shown in figures (Fig. 8-9) respectively.

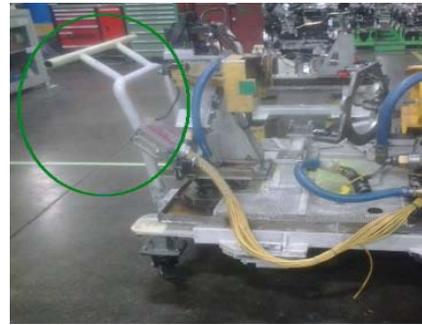
Fig. 9 Cart Handle Improvement After Implementation

- Time saved by these cart handle improvement is 10 sec per engine.
- Bending moment and fatigue saved for 200 engines per day.
